# 19. Sector – Futog (km 1,267.4 – 1,261.6)

# 19. Futog – Existing situation

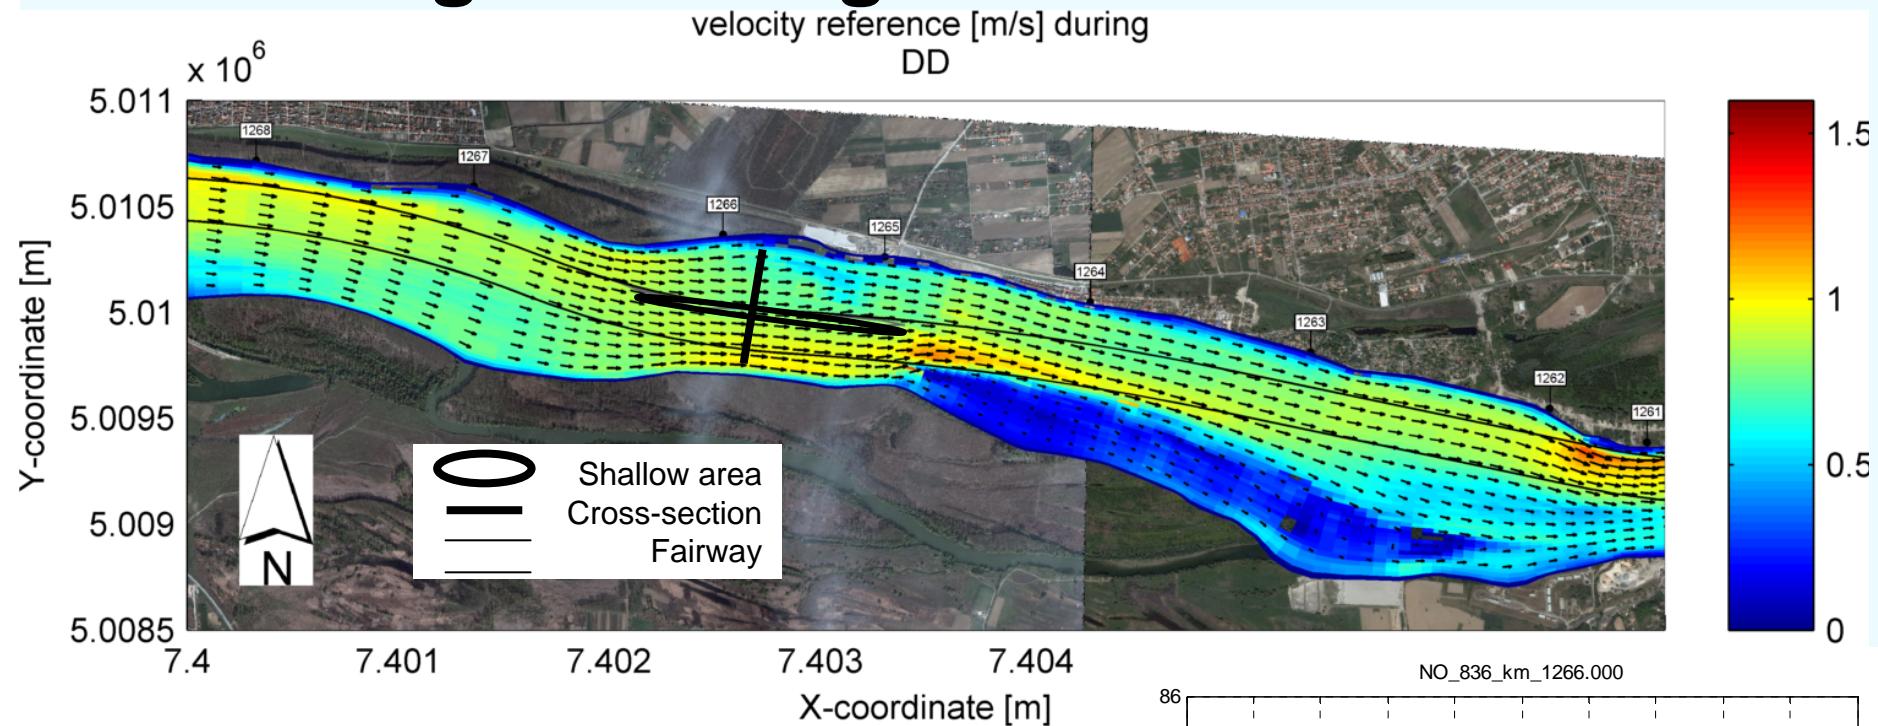
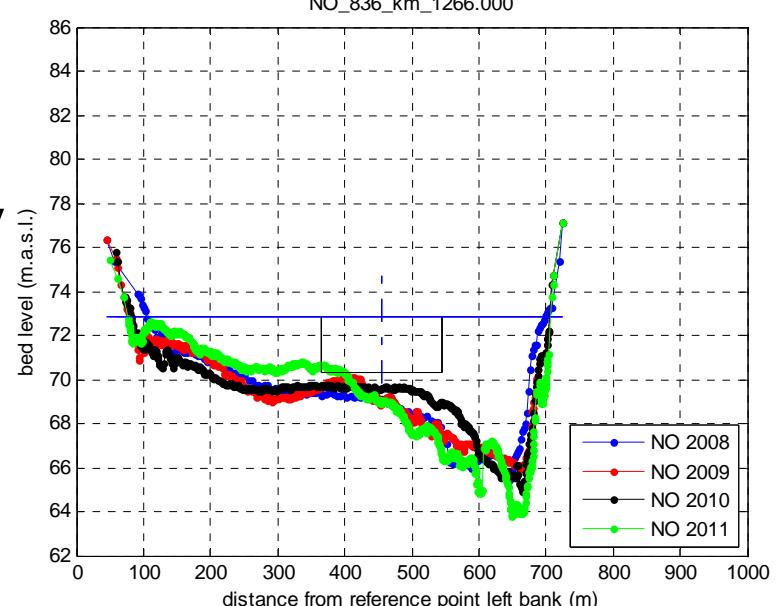
# 19. Futog - Existing situation

Navigation problems:

- Upstream: bar protudes into fairway along left side of fairway;
- Downstream: unstable river bed
